Model	Other model names	Date	Revision	Revision date
Revolution Troubleshooting		2022-04-06

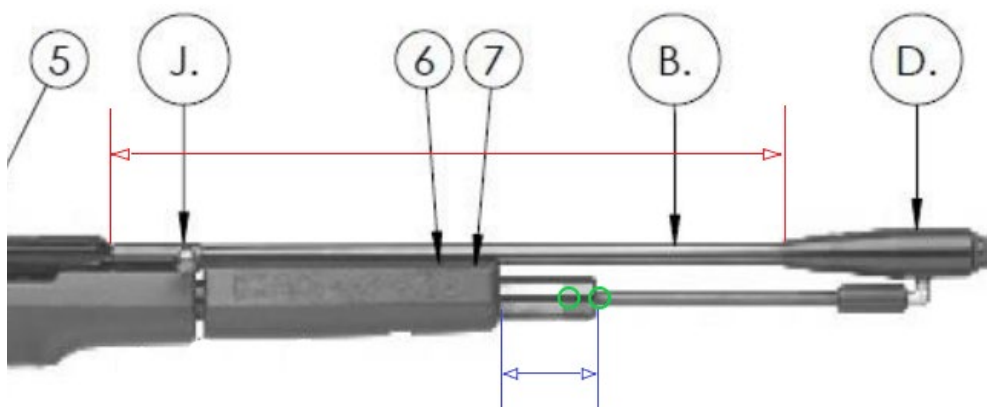
3. Expansion chamber (D) has moved from it's original position.
Should be seated 385mm from the breech block (red marking in the picture).
4. Reloading chamber (B) has moved from its original position.
Should be seated 55mm from the stock (blue marking in the picture).

9. Reloading pressure: Later models of Revolution has an air evacuation adjustment (B3). Here you can adjust the force of the reloading. If it feels like it reloads to hard you might want to release some of the air or if you have attached a Silencer. You simply open it up so it releases some of the reloading pressure by adjusting the screw counter-clockwise. If fully closed (maximum reloading pressure) you should see threads from the screw (B3) in the evacuation hole. If fully opened you will not see the thread (minimum reloading pressure). Reloading adjustment area marked green in the picture.
